EMBRAER E-190 FIELD RECOVERY, CUENCA, ECUADOR

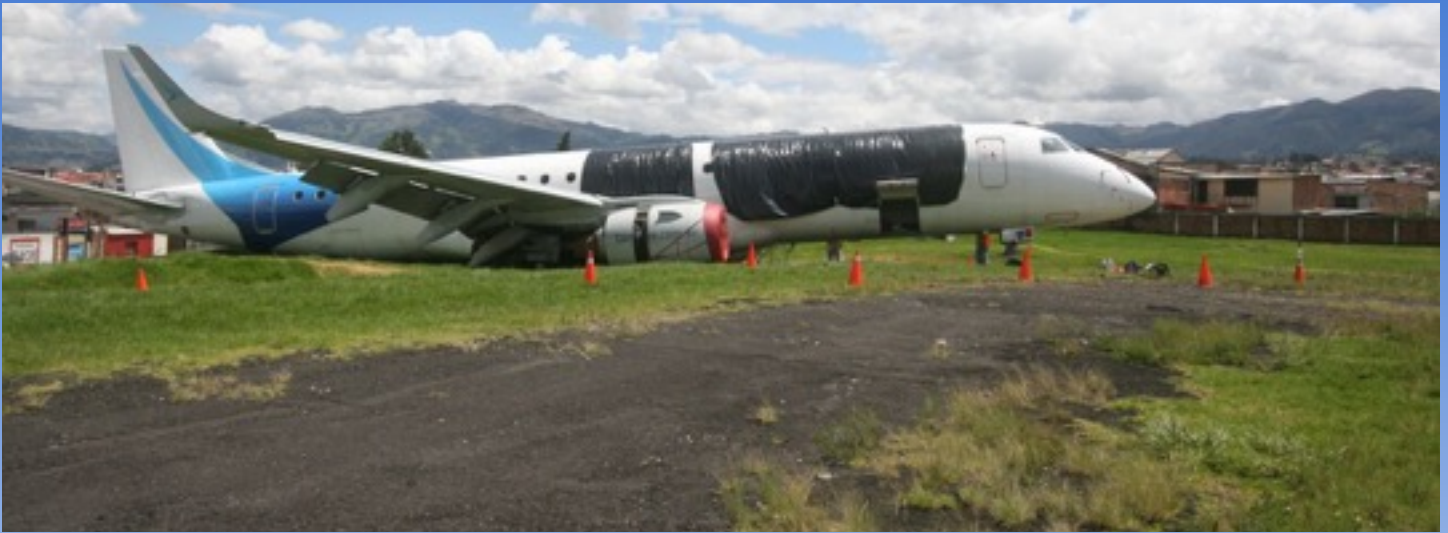
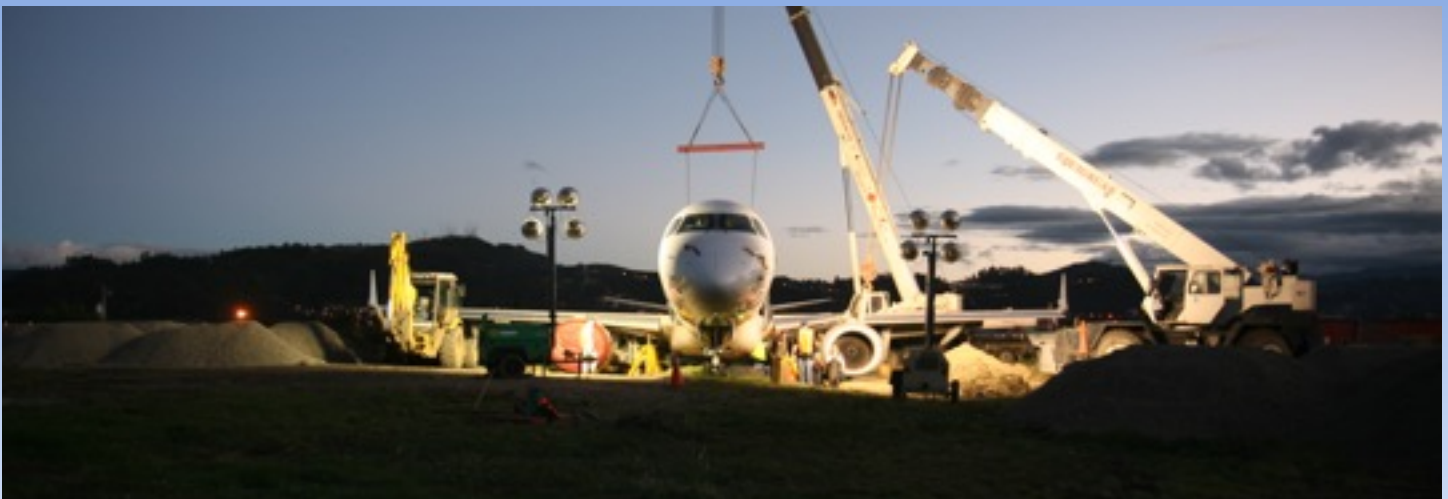
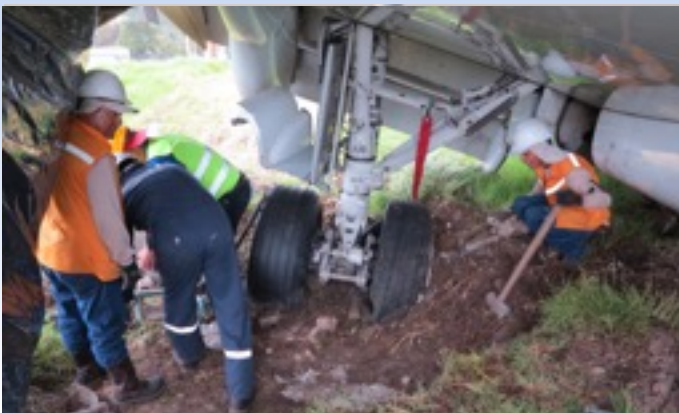
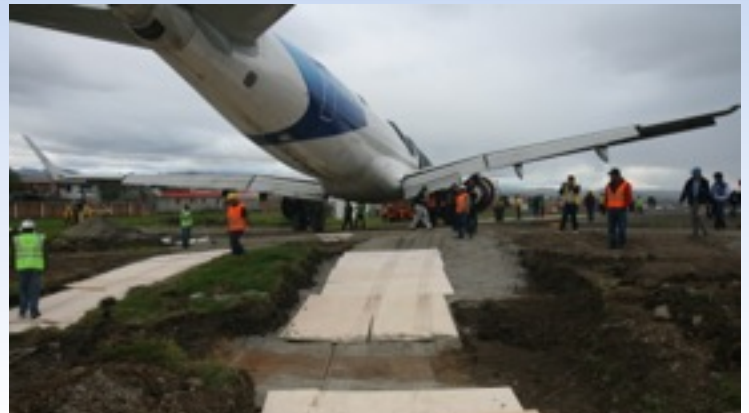
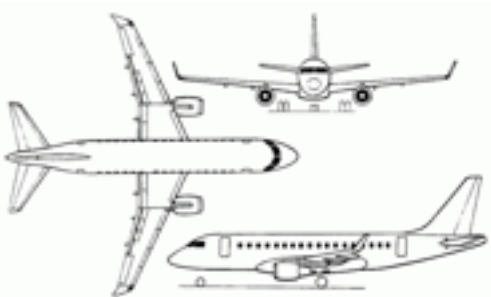
The aircraft overran the runway by a reported 70 meters from the end of the runway. One main gear collapsed and one main gear was partially buried in a ditch.

The aircraft Center of Gravity was restored to prevent the aircraft moving backwards over the perimeter wall and into the street, its landing gears

extracted and restored, engines and equipment secured and a short impacted road built back towards the runway. The aircraft was successfully towed back to the tarmac without any additional damage after 4 days of heavy work by all companies and agencies working together under the direction of SOAR .
