## BOEING 767-300 REPAIR & MODIFICATION, MEDINA, SAUDI ARABIA

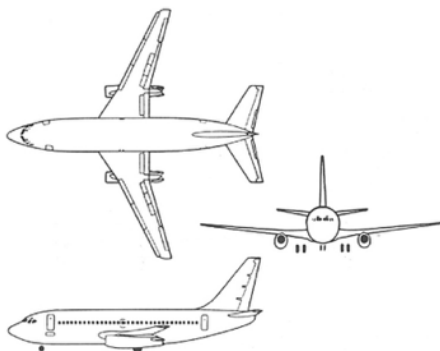
The aircraft landed with one main gear retracted. The lack of local infrastructure did not support the heavy structure repair & pylon modification that was required.

Work scope included fuselage damage repair, engine strut replacement & engine strut wing interface modification.
