707-321 TANKER LOWER BULKHEAD REPAIR, VICTORVILLE, CALIFORNIA

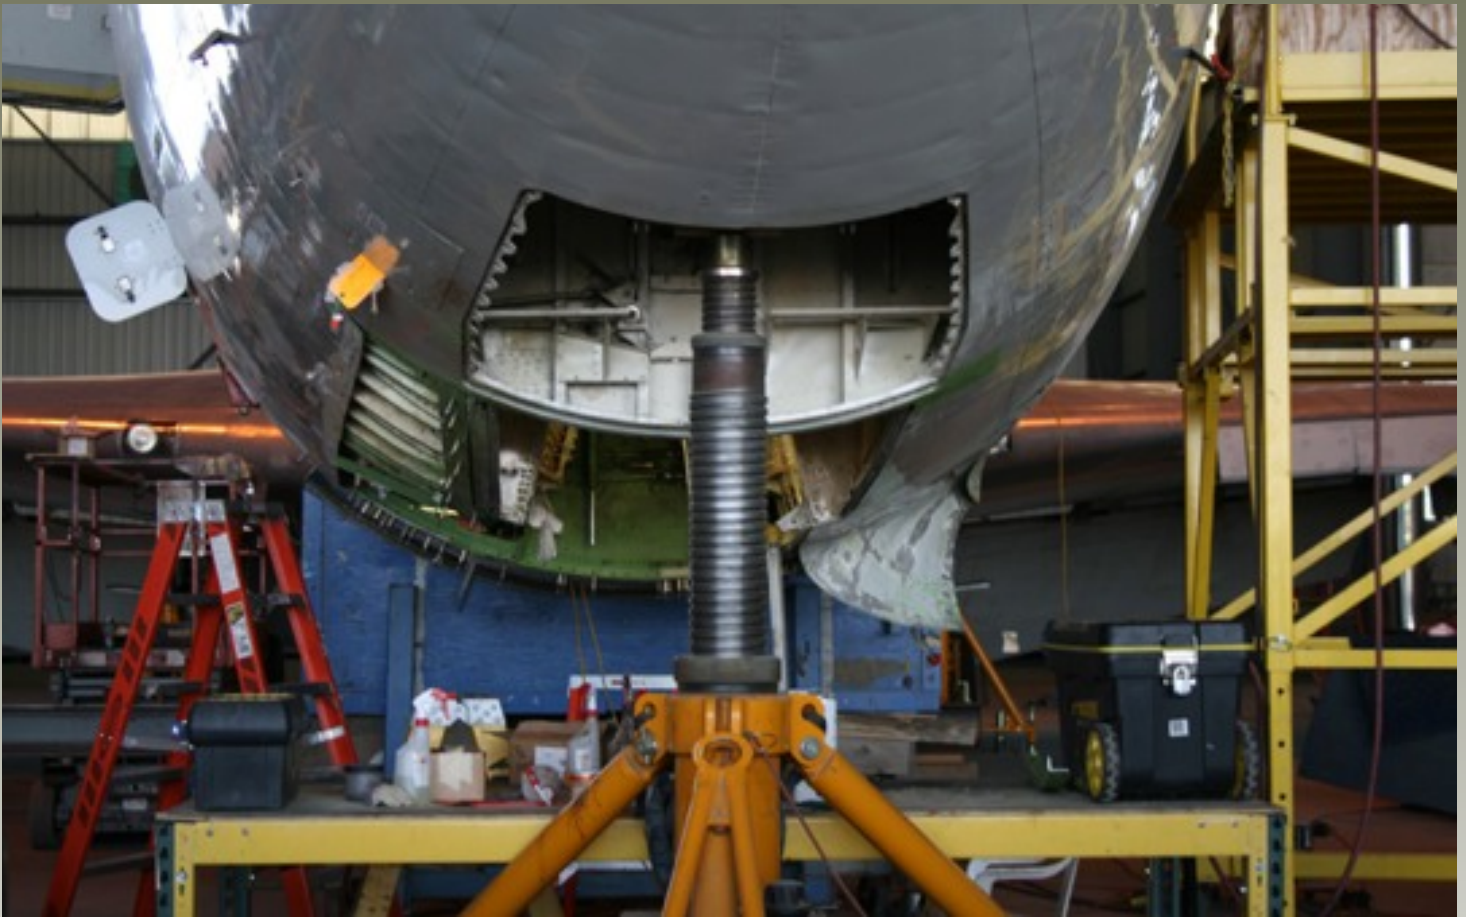
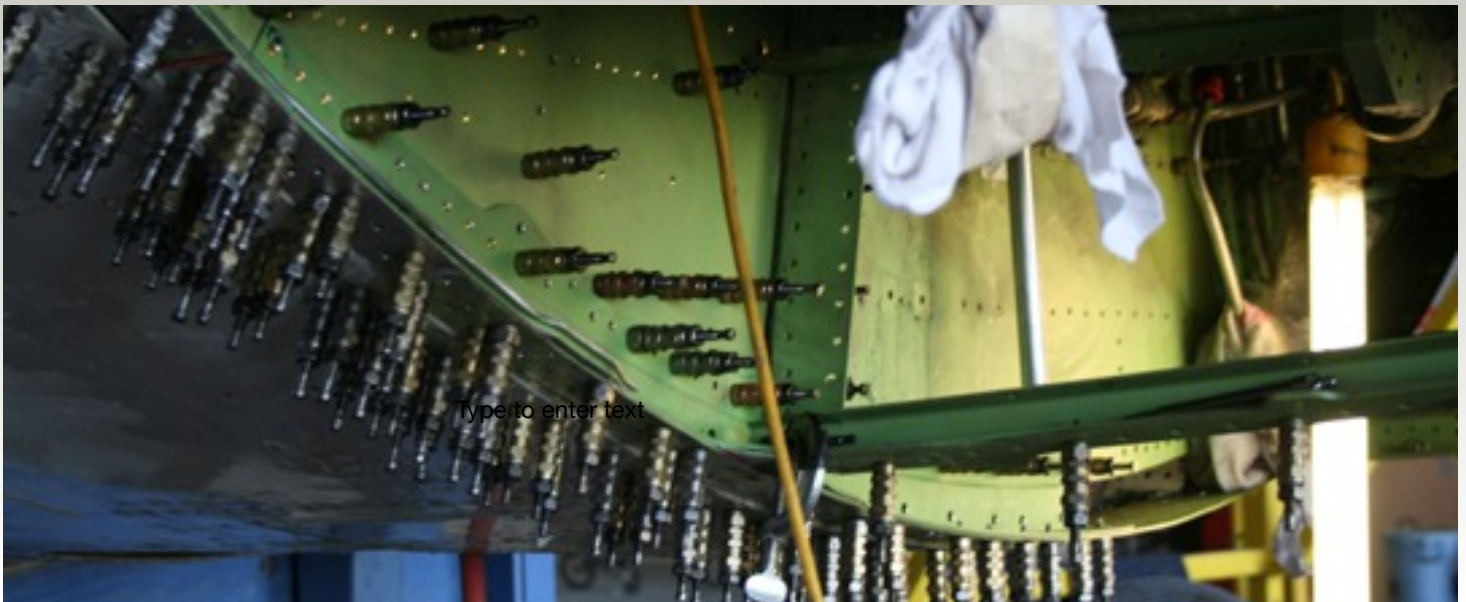
The client aircraft received damage within the lower bulkhead after a hard landing, due to a poor quality previous repair and substantial accumulation of corrosion. SOAR was contacted by a local MRO to take over the structural reconstruction (the MRO did not have the experience) and responded with a comprehensive quote 24 - 48 hours after initial contact. Qualified personnel with heavy structural

The scope of the project included the installation of the repair caps, multiple skins, splices and web, as well as repair to additional local structures caused by corrosion. In addition, SOAR provided engineering repair drawings. DER sign-off of repair via FAA Form 8110-3, personnel logistics and specialty tooling as required.
