## A340 RECOVERY, EVALUATION AND TEAR DOWN, QUITO, ECUADOR

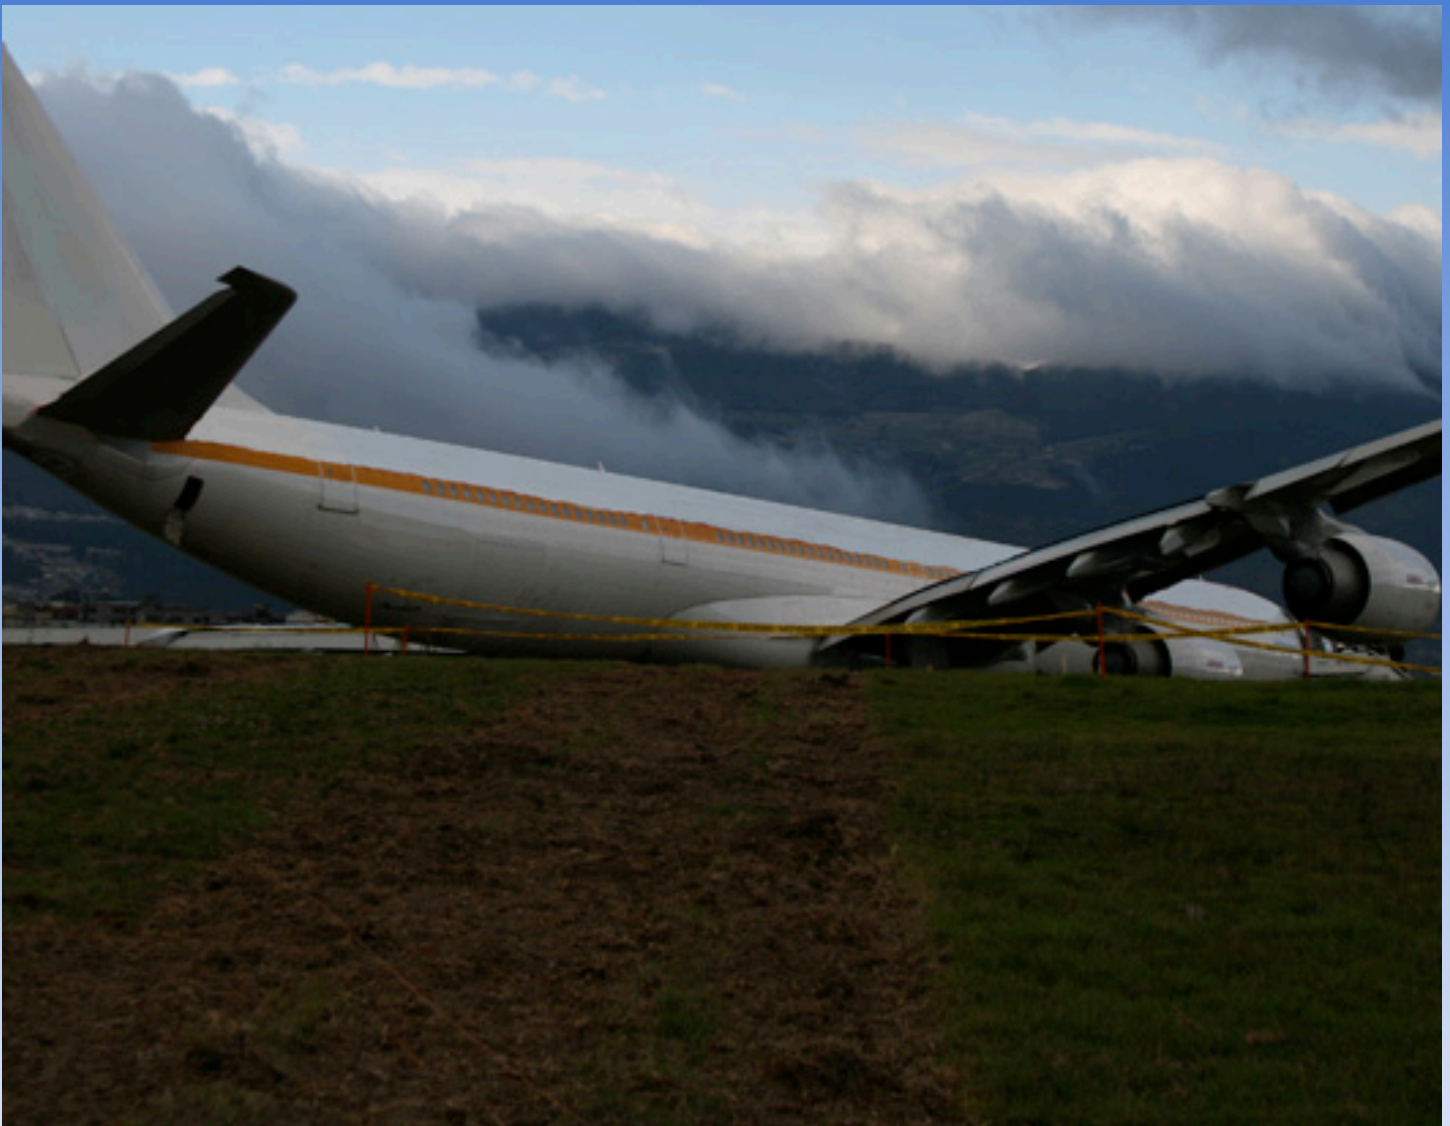
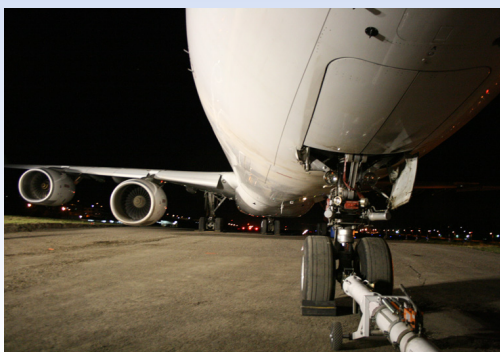
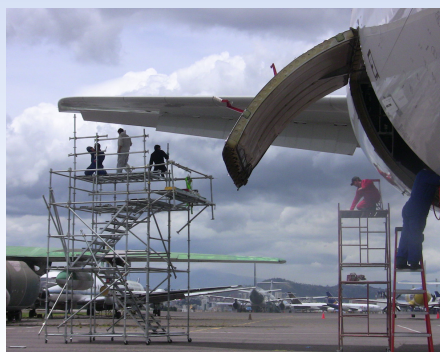
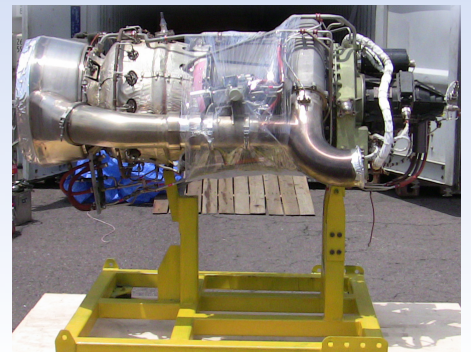
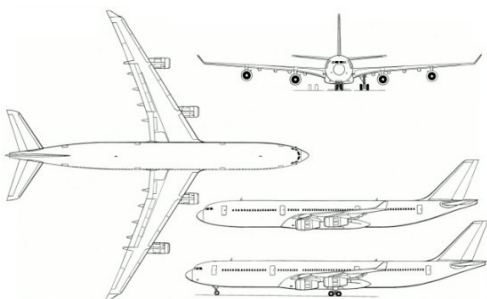
The aircraft overran its runway and came to rest 550 yards away on a downhill slope just short of a neighborhood.

Project scope included creating a 400 yard compacted road and towing the craft back to the tarmac on restored landing gear for further inspection. It was determined that the aircraft would not be repaired and SOAR was contracted to

dismantle the A340 for parts and value recapture.

SOAR supervised the recovery, evaluation and disassembly, which required careful documentation of inventoried parts via an electronic database and photo documentation.
