707-321 TANKER LOWER BULKHEAD REPAIR, VICTORVILLE, CALIFORNIA

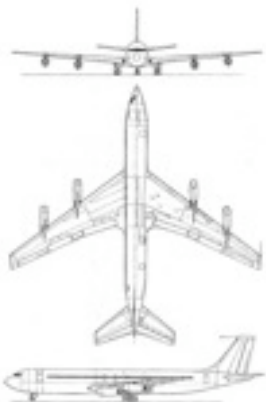
The client aircraft received damage within the lower bulkhead after a hard landing, due to a poor quality previous repair and substantial accumulation of corrosion. SOAR was contacted by a local MRO to take over the structural reconstruction (the MRO did not have the experience) and responded with a comprehensive quote 24 - 48 hours after initial contact. Qualified personnel with heavy structural

The scope of the project included the installation of the repair caps, multiple skins, splices and web, as well as repair to additional local structures caused by corrosion. In addition, SOAR provided engineering repair drawings. DER sign-off of repair via FAA Form 8110-3, personnel logistics and specialty tooling as required.
